Certificate of Conformance for Freight Container Mechanical Seal Testing
Seal Classification: High Security Seal

試驗報告 TEST REPORT

Test Report No. : M0215091-T01

SUBJECT : Freight containers Mechanical seals classification Testing

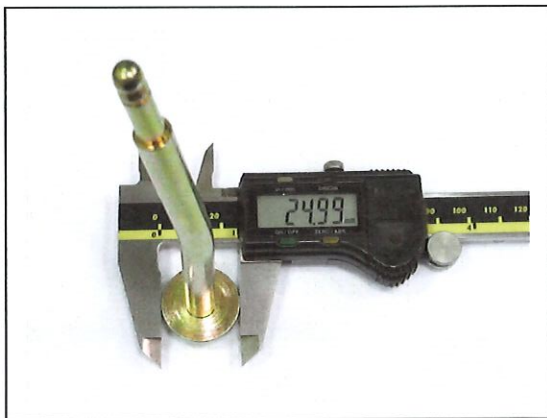
Specimen No.	Measurement (mm)		Pass/Fail
000086	Pin Head	24.99	Pass
	Lock Body	18.47	Pass

The minimum diameter (or minimum widest cross-dimension) for the metal components of a bolt seal shall be 18 mm.

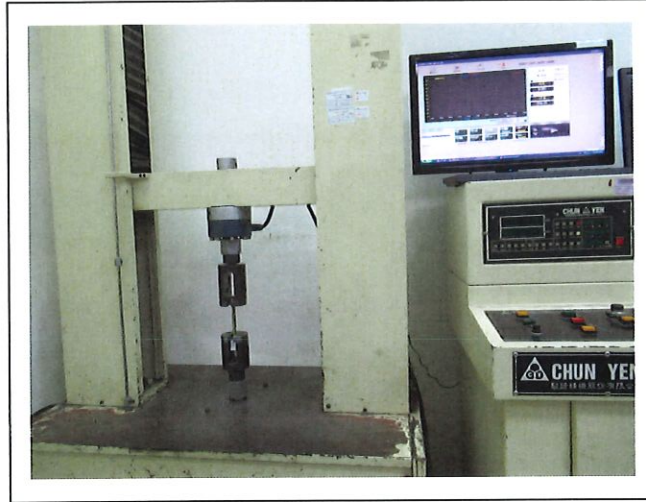
Testing Instrument : Universal Testing Machine (No.TG0103)

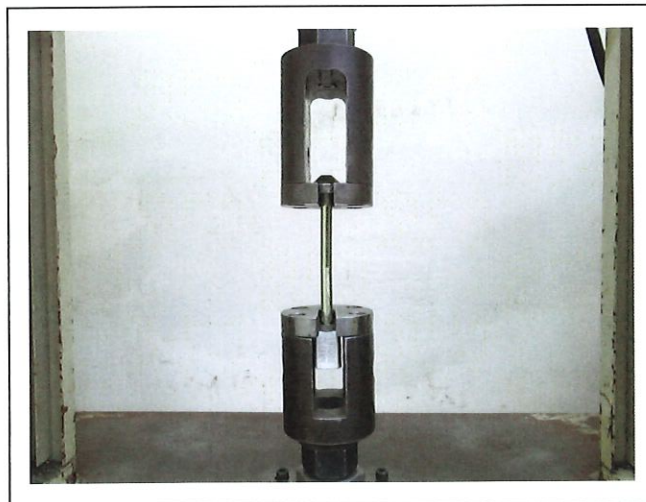
Tensile Set up

The seal was gripped in a tensile machine and a pull force applied.

Specimen No.	Requirement Load to failure	Result kN	Seal classification
000061	10.0 kN : High security seal 2.27 kN : Security seal < 2.27 kN : Indicative seal	44.1	High security seal (H)
000062		43.4	High security seal (H)
000063		37.5	High security seal (H)
000064		38.5	High security seal (H)
000065		35.5	High security seal (H)

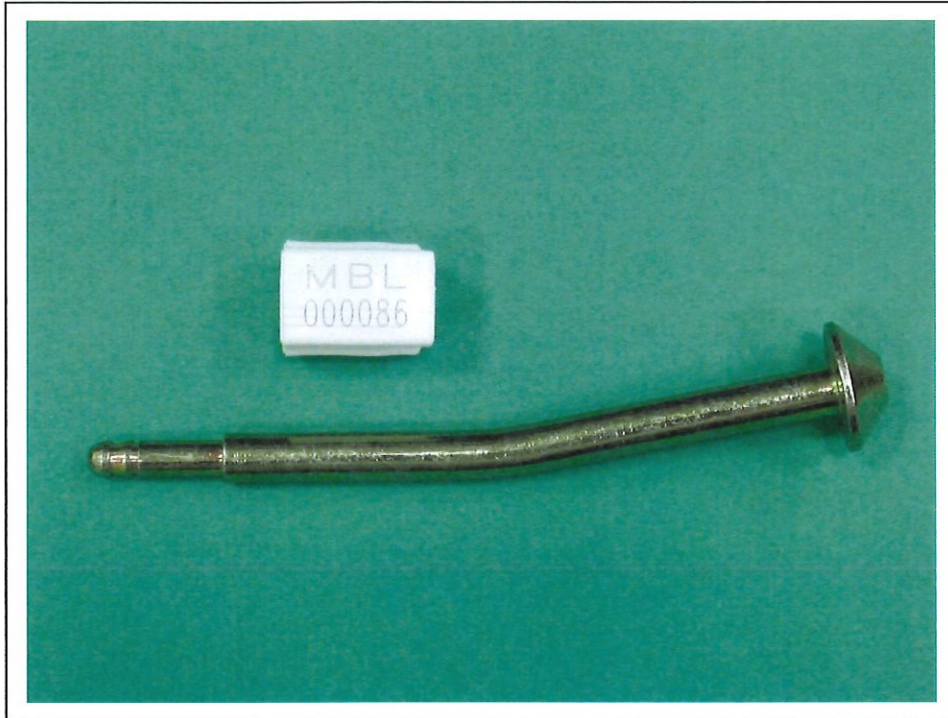
Name of Article : High Security Seal

Type : Mega Bolt Lock (MBL)
