Certificate of Conformance for Freight Container Mechanical Seal Testing
Seal Classification: High Security Seal

試驗報告 TEST REPORT

SUBJECT : Freight containers Mechanical seals classification Testing

Name of Article: FORT CONTAINER SEAL MEGALOCK

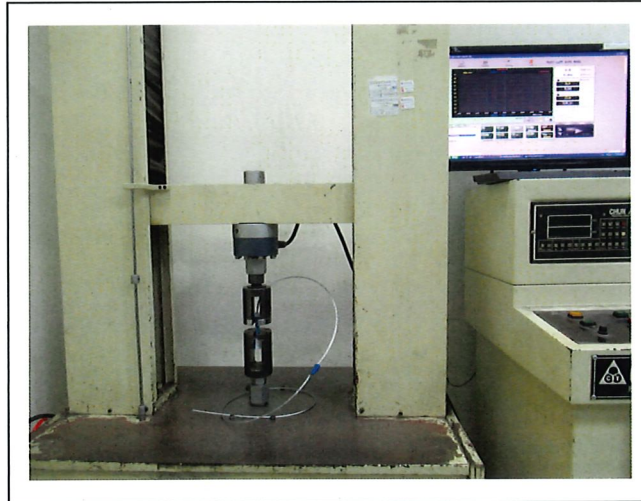
Testing Instrument : Universal Testing Machine (No.TG0103)

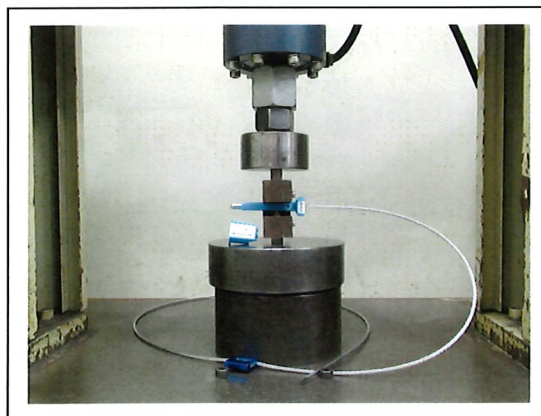
Shear Set up

The seal was fixed in a universal testing machine to withstand cutting with shearing blades and a compressive load applied slowly until the seal is severed.

Specimen No.	Requirement Load to failure	Result kN	Seal classification
M000036	3.336 kN : High security seal 2.224 kN : Security seal <2.224 kN : Indicative seal	8.896	High security seal (H)
M000037		8.896	High security seal (H)
M000038		8.896	High security seal (H)
M000039		8.896	High security seal (H)
M000040		8.896	High security seal (H)

SAFETY PRECAUTIONS - Do not exceed a shear force greater than 8900N(2001lbf). If the specimen has not failed at that force, halt the test and unload the test equipment. Record a shear force of 8896N (2000 lbf). Sudden and violent rupture of the test specimen can endanger personnel, equipment and property.

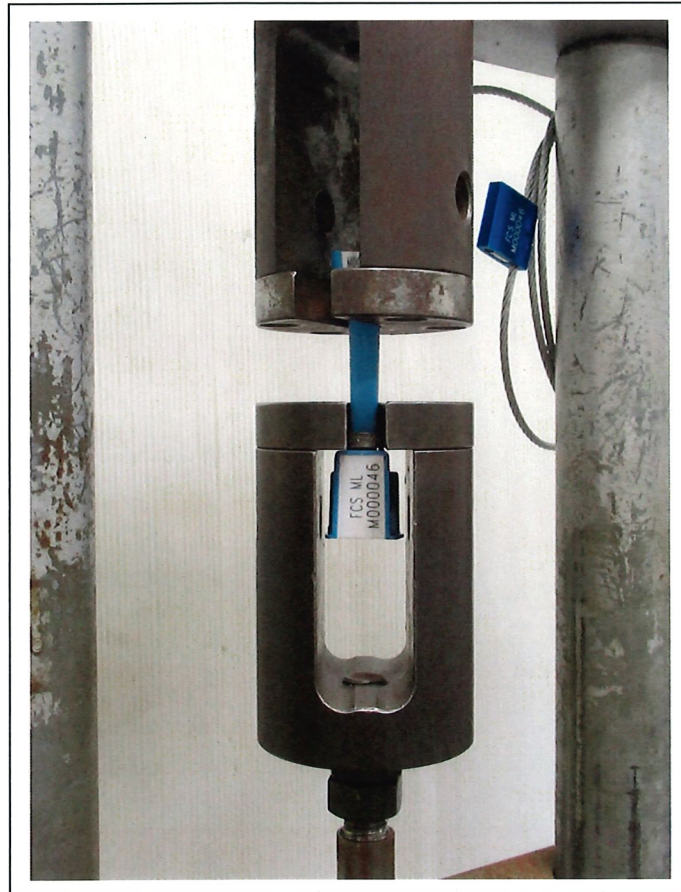
Impact Set up

The impact test is performed at 18 degrees Celsius and minus 27 degrees Celsius of temperature.

The impact load is applied at the locking mechanism of the seal in the direction

opposite the direction used in locking the seal.
